The Seawind Flyer

Fall 2011

FLIGHT TESTING CONTINUES

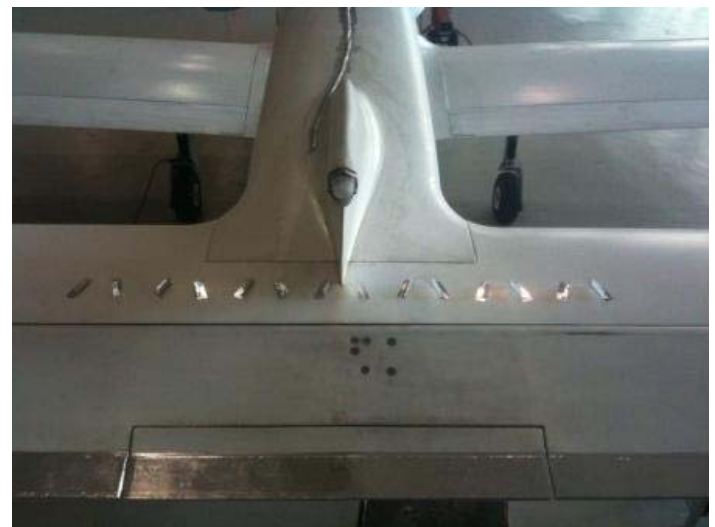
The VGs enhanced the elevator trim tab for rotation.

John increased the airstream across the elevator trim tab using large VGs, and the rotation is now compliant even though the stick force is a little higher than on the experimental version. In the meantime, we are trying to slightly increase the elevator nose-up angle by 2° or 3° for the same stick force by using low-friction pulleys. We will check it one more time and, if successful, we will remove or reduce the size of the VGs. If not, we will settle on the VGs.

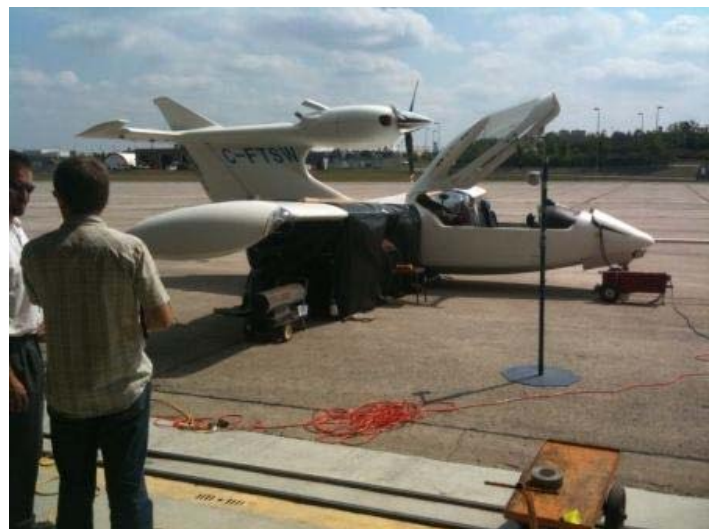
Using a 1,000,000 BTU heater and a black plastic tent we heated the fuel to 111°F.

In order to heat the fuel, we moved the Seawind out on the tarmac in the sun and we covered the wings with black plastic and draped the plastic to the ground to

form a tunnel from one wingtip to the other. We then fired up a 1,000,000 BTU-per-hour heater.
