# The Seawind Flyer

Spring 2011

## THE EVOLUTION OF AN INTELLIGENT DESIGN

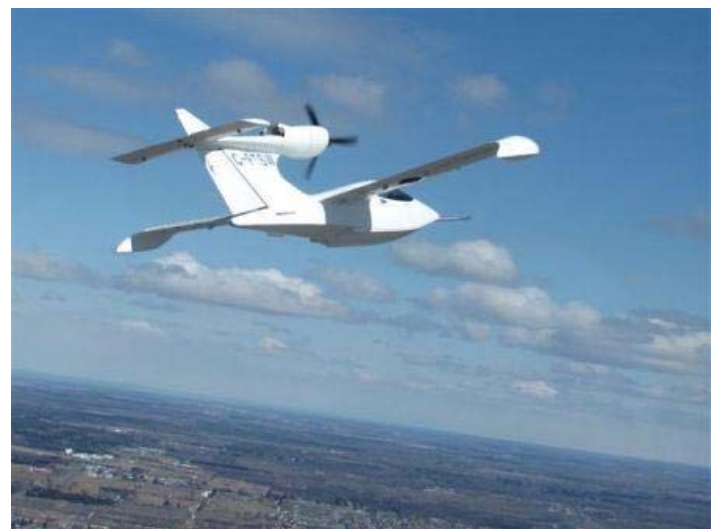
*The Seawind departing Ottawa Airport for the final dive speed flutter flight.*

The most hazardous full-fuel 200-knot (230 mph) Vne speed (never exceed speed) and 210-knot (242 mph) Vd (dive speed) flutter tests were completed on March 23 with flying colors (pun intended). We completed the low-fuel flights on March 24.

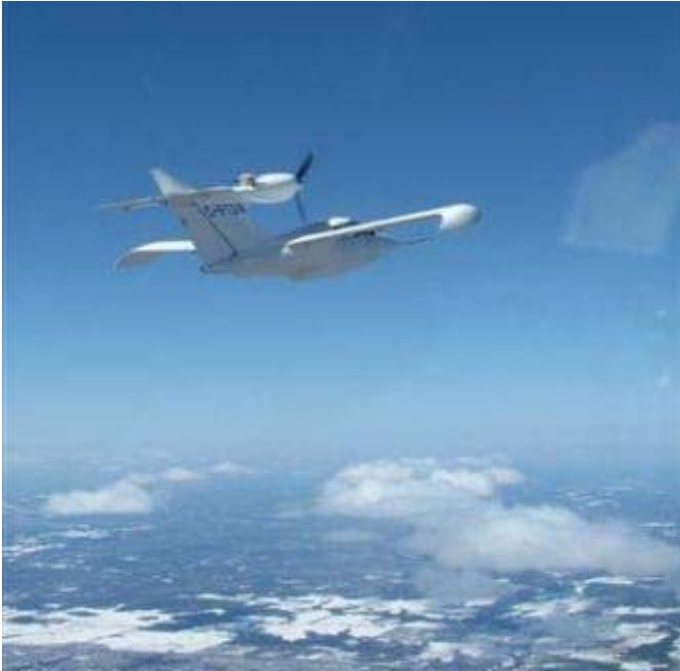
*We had to simulate 10 years of wear without adequate maintenance.*

Little did I know that we would be required to test with intentional wear simulated on each trim tab and trim tab flutter damper. Then we had to slacken the aileron, rudder, and elevator cables.

Then we had to imbalance the balance weights on all three control surfaces. That's when I began to worry.

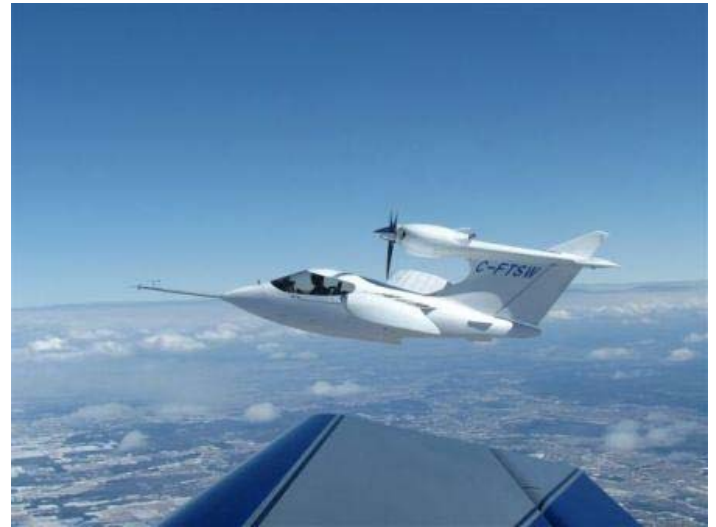
*The Seawind climbed to 15,000 ft. to accelerate to dive speed before reaching 13,000 ft. Notice the data collection boom off of the nose.*

The Vne and Vd required that the pilot had to climb to 15,000 feet in order to execute the maneuver. Then the pilot pushed the nose over to be able to reach the test speed rapidly before descending to 13,000 feet to start recording data and then ending the test at 10,000 feet. We wound up doing all the heavy fuel load tests first.

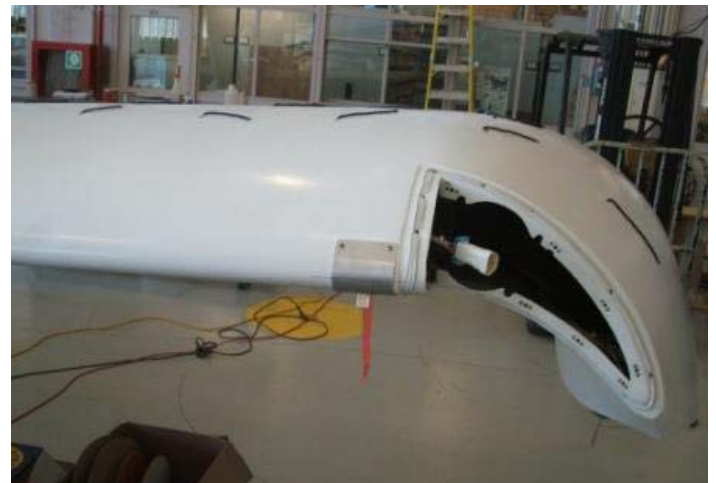
*The AoA sensors are located outboard of the extended range fuel tanks, inboard of the landing lights.*

The Seawind went back in the hangar for the last week of March for the installation of the SPS. It has been completed. The system will be flight tested and calibrated starting the first week of April. At the heart of the system are two angle of attack (AoA) sensors, which have been mounted under the leading edge of both wings.

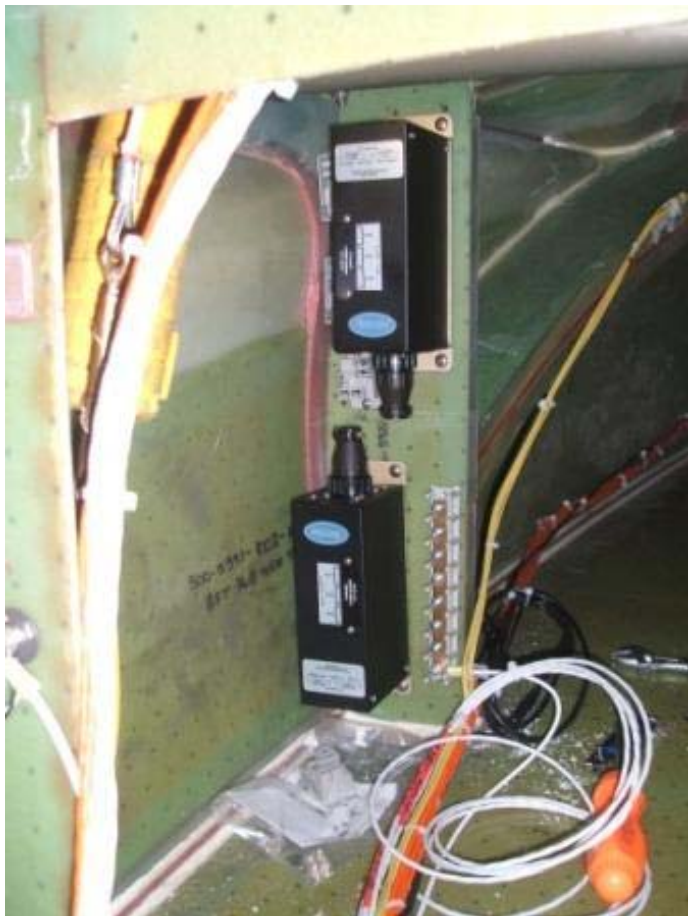
*The sensors drive the dual computers in the aft hull compartment.*

They feed two analog computers, which are the brain of the system. There is a means for the pilot to override the system if necessary.

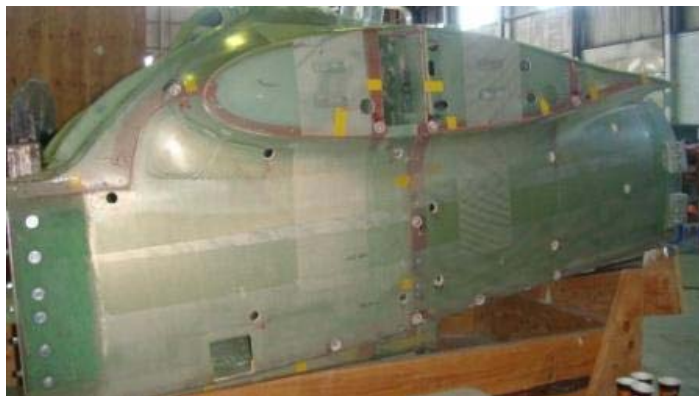
*Visible hole damage was added on the left side of the fuselage midsection.*

The testing had been completed for one-and-a-half lifetimes when it was interrupted to induce large hole (visible) damage in addition to the disbond damage and the small hole (barely visible) damage incorporated at the start of testing. In addition, 10 repair procedures were just performed on the wing and fuselage by cutting into the wing and fuselage and then performing the repair. As difficult as it may be to get a hole in the structure, we must have an approved repair procedure that has been fatigue tested. We will now complete the second lifetime of testing equivalent to 24,000 hours of flight and take the structure to ultimate at the finish. The number of intentional defects, holes, and repair procedures is over 500 just in one wing and the mid-section of the hull.

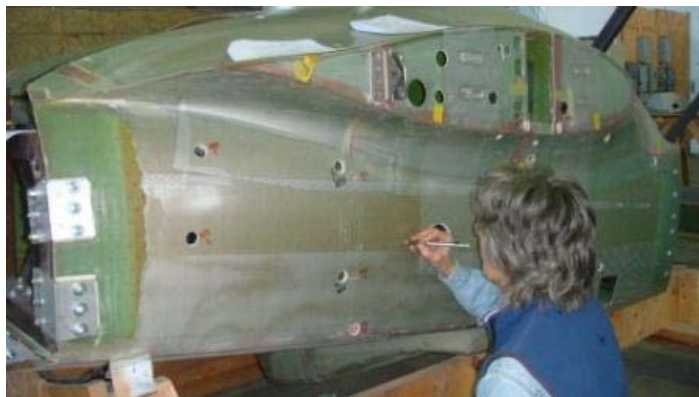
*One repair procedure on the right fuselage and over 80 visible open holes in the one wing and mid fuselage.*
